ARRT Project Summary

Project Title/Name: Crows Hole Sediment Trap

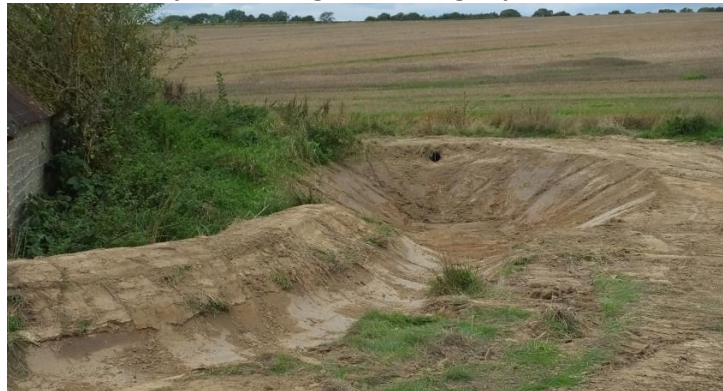
Below: Additional field-corner trap that fed into the same field-ditch trap (above, right) draining adjacent field

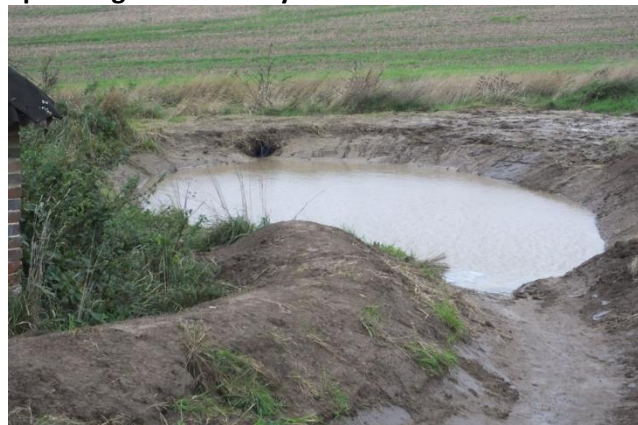
Below: Additional field-corner trap at Crows Hole, full & operating well: January 2014

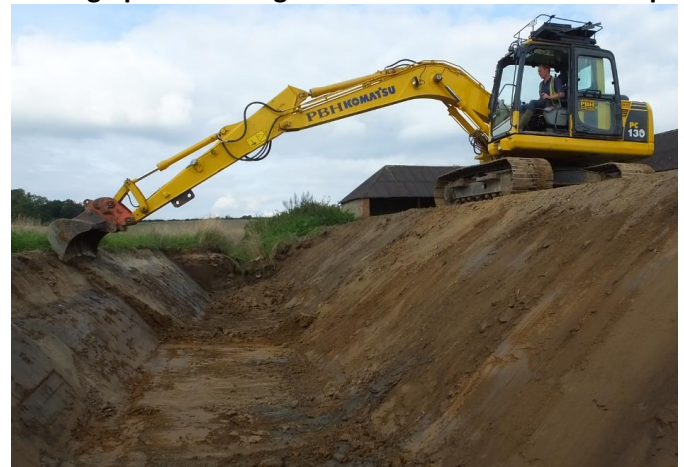
The Construction Works: Excavation of In-Ditch Trap - looking up the existing field ditch that will fill the trap

In-ditch field traps such as that trialled at Crows Hole were found to be harder to clear and empty compared with field-corner traps. This is because the traps have to be isolated from flowing ditch water during their excavation and maintenance works. This proved to be problematic as the traps are fullest during the winter when field ditches are often continuously flowing with surface runoff. By-passing field ditch runoff around the trap during excavation works was achieved at the Crows Hole trap via an existing land-drain that circumvented part of the field, however, the naturally highly erodible soils meant that ditch runoff could often find its way back into land drains rather than to the

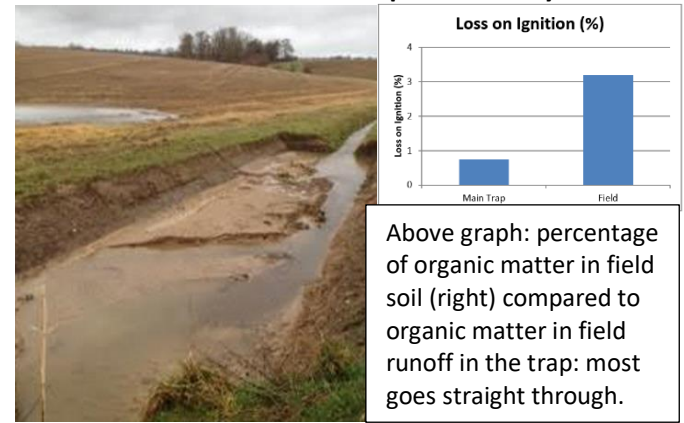
Below: Crows Hole In-Ditch Trap Full January 2014

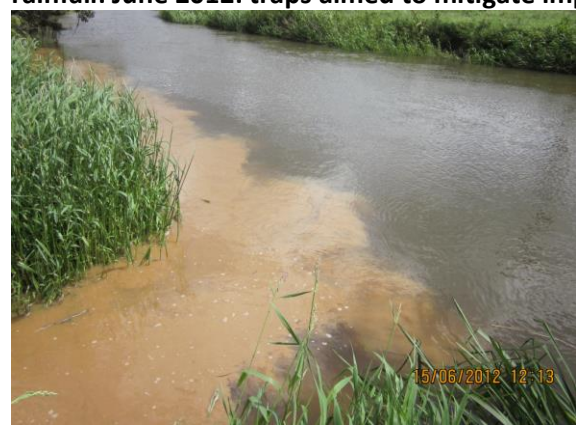
Below: Diffuse agricultural pollution after summer rainfall: June 2012: traps aimed to mitigate impacts
